Wisconsin Construction Safety Newsletter

Do you know fall hazards when you see them?

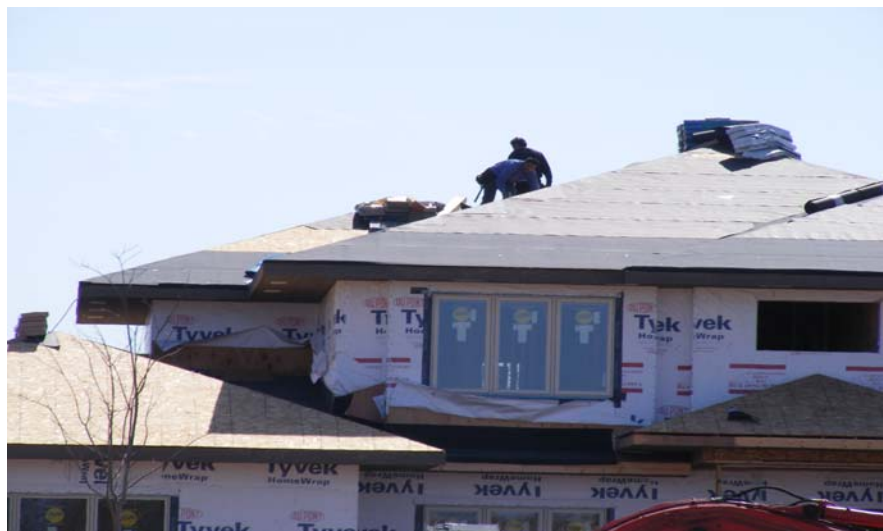
No fall protection
being used.

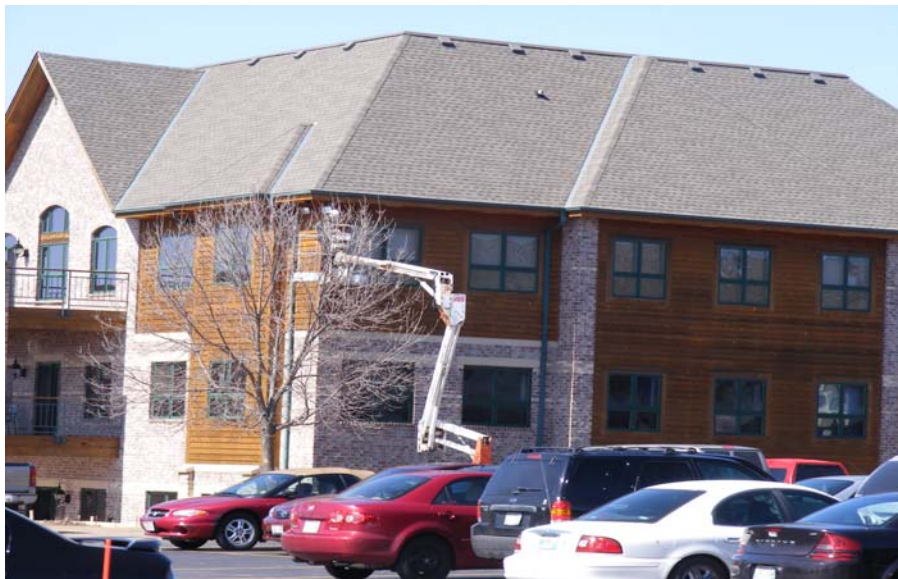
No fall protection being used.

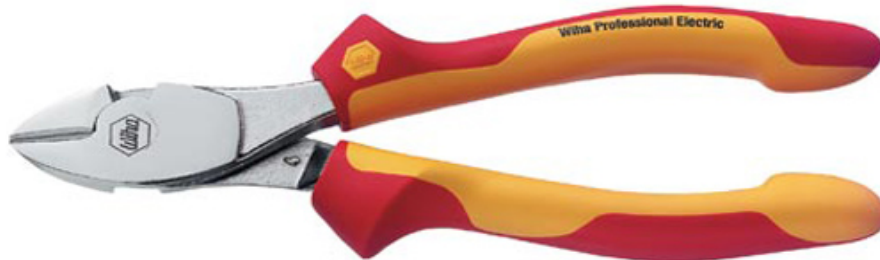
Typical pliers with electrical insulation.

Some hand tools such as electrically-rated lineman's pliers have insulated handles that are designed to withstand specific voltage levels – for example, 1000 volts a.c. The coated pliers that most workers use are not electrically rated. Insulated hand tools must be covered with material that protects the user from electric shock and minimizes the risk of a short circuit. The American Society for Testing and Materials (ASTM F1505) and the International Electrotechnical Commission (IEC 60900) specifies the requirements for selecting and using insulated hand tools.

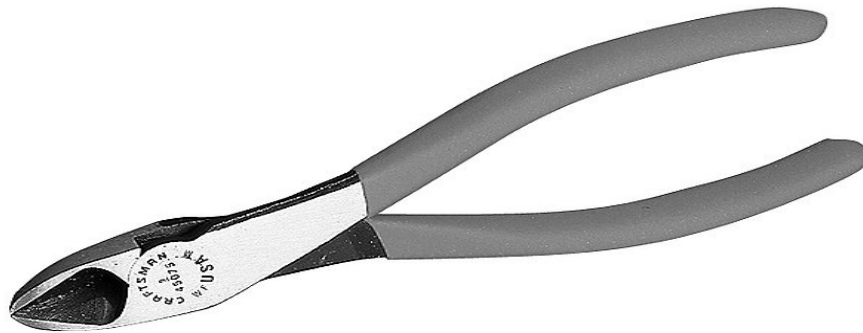
Typical pliers with comfort grips.

Recently, while removing lighting on a demolition project, a worker inadvertently cut an energized power cord with a pair of pliers that caused a spark and a hole in the cutting portion of the pliers. The worker used pliers with plastic-coated handles made for ergonomic comfort; however, this type of coating doesn't insulate against electrical current and doesn't provide a complete safety barrier.

Never assume that a hand tool is acceptable for work on energized equipment because it has a plastic coating on its handles. Although insulated hand tools must meet specific industry standards, they provide only a partial barrier from electrical hazards. The safest way to work on electrical equipment is to make sure that it's de-energized before you begin.

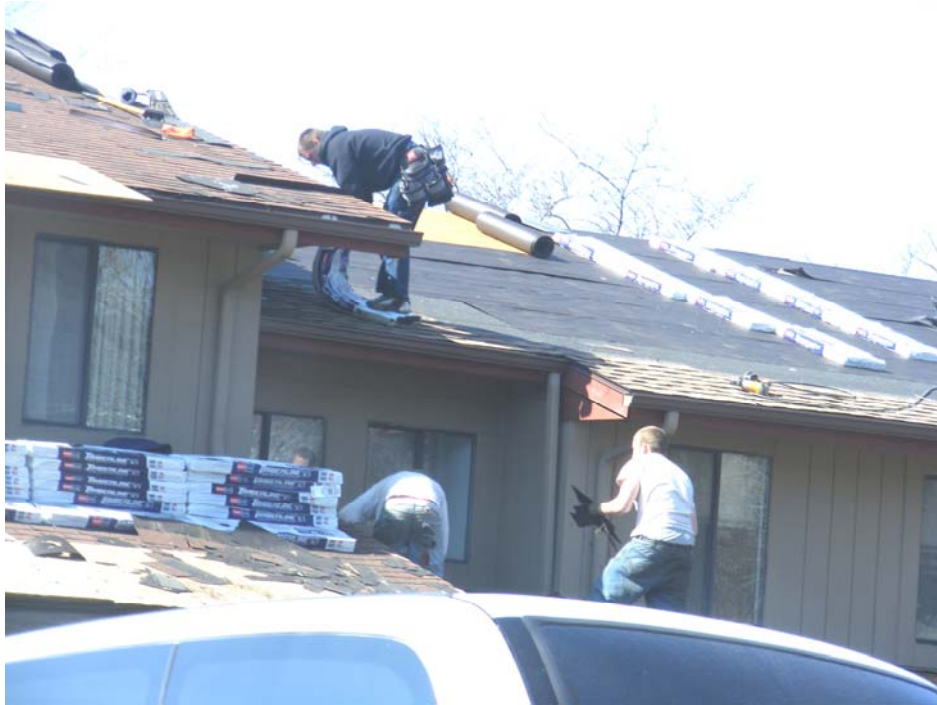
No fall protection being used.

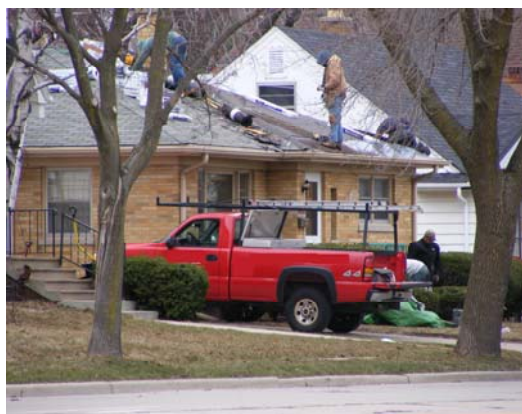
No fall protection being used.

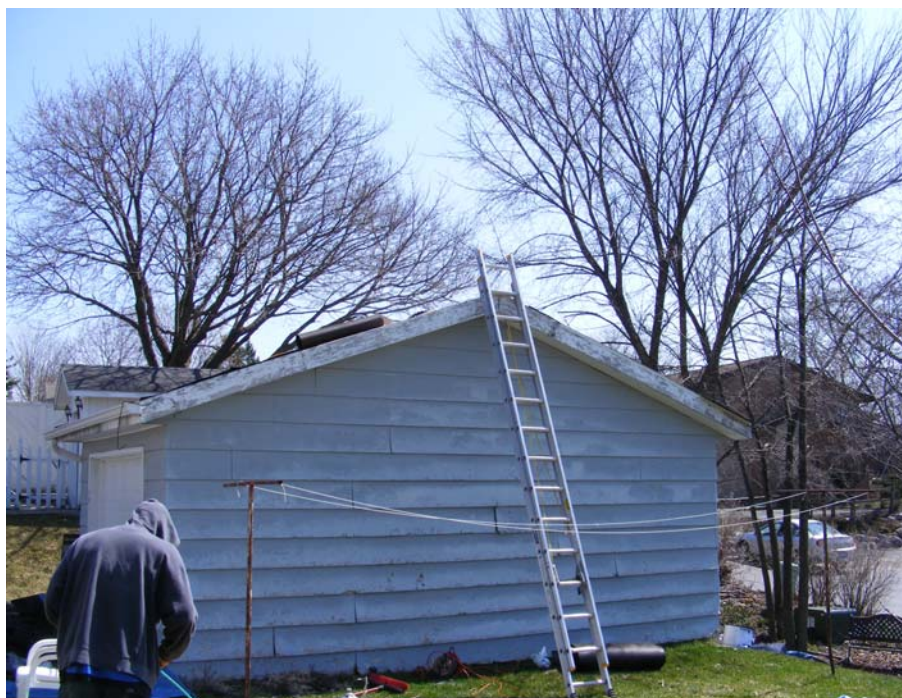
Ladder does not extend 3 feet past the top edge.

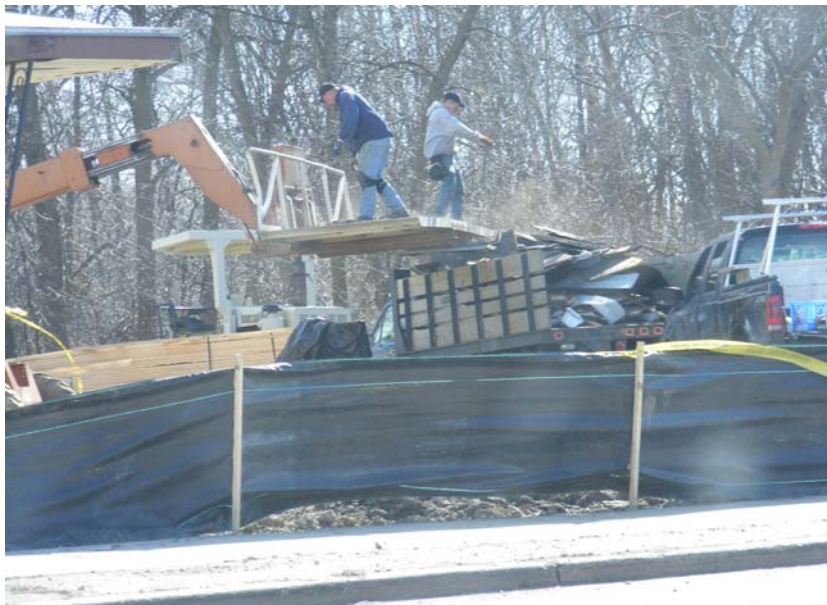
No fall protection
being used.

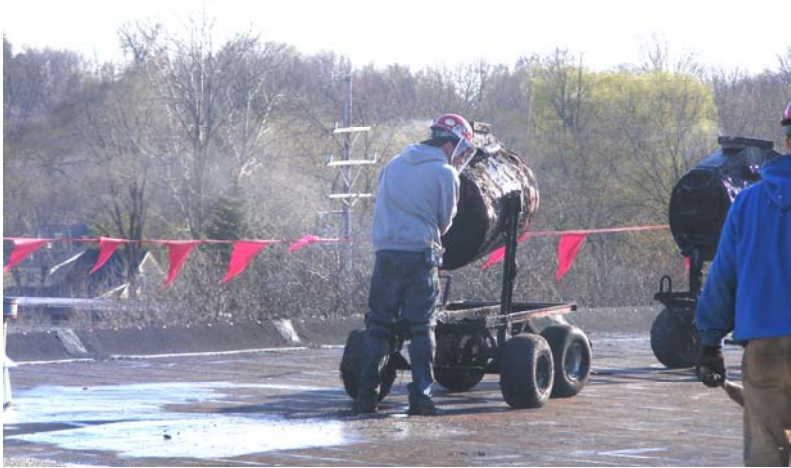
This employee fills a bucket with hot asphalt from the portable tank, carries it across the roof and pours the asphalt. He was exposed to asphalt fume at 0.86 mg/m^3 during a 224 minute sample. The 8 hour average exposure would be 0.40 mg/m^3 . The ACGIH TLV is 0.50 mg/m^3 .
